FRIM NEWS

Issue No. 104 May 2023

Senna siamea Novel Grub detected in some parts of Malawi Davie Moyo & Herbart Jenya

Wilting and Dying of Eucalyptus Dunnii in Mbalachanda, Mzimba

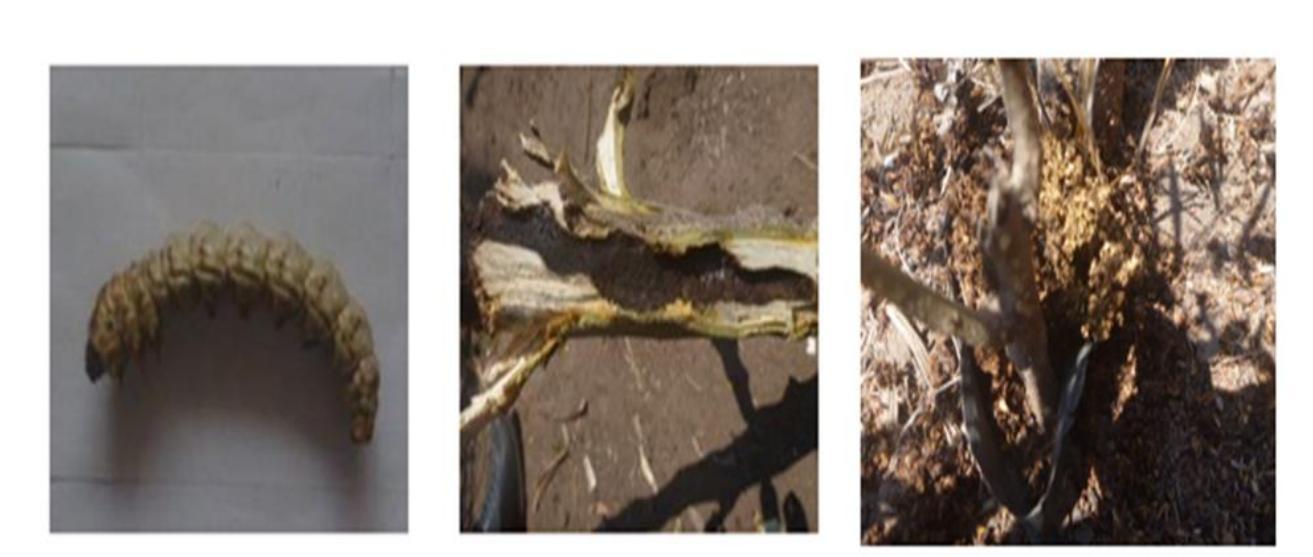
Preliminary field observations revealed that the borer (Figure 1A) is big enough to inflict a big injury to the affected tree stems. The stem borer bores into the stem (Figure 1B) and as it grows it tunnels downwards hollowing out the main root. The larva ejects the frass through a hole in the stem just above the ground level and the frass accumulates at the base of the stem (Figure 1C).

Fig 1: (A) Grub of the borer (B) Gallery (Tuneling) (C) Bore frass at the base of the stem (Pic: Herbart Jenya)

The larva has not yet been identified in terms of species name because the process requires some molecular techniques and no adult beetle has been observed, but it is suspected to be the larvae of a long-horned beetle (*Coleoptera: Cerambycidae*). Larvae of most *Cerambycidae* bore in the cambium and wood of living trees, logs or wood in use. Others bore in stems and roots of herbaceous plants. They are known as round headed wood borers because they produce rounded or slightly oval exit holes when emerging from infested trees or logs. Some infest weakened or recently dead trees and others can infest living trees. Many are considered pests because they weaken the structural integrity of living trees or wood in use, reduce the quality of lumber, or function as vectors of tree diseases. Some are known to kill trees. Some species spend long period in the larval stage in wood and can be transported long distances via logs, wooden crating, pallets, dunnage or fuel wood (Bybee et al. 2004). As a result, several insect species have been established in new locations dying in Mbalachanda in Mzimba. FRIM organized a trip to visit the and become pests.

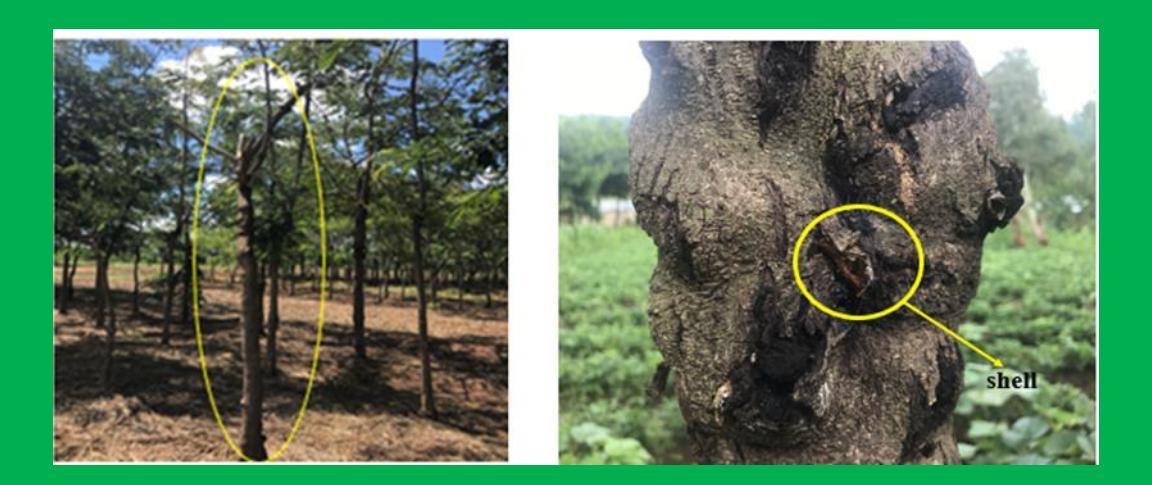
The stem borer attack results in tunnels in the tap-root and the stem immediately above ground. The tunnel may reach about 40-60 cm in length and in worst cases, the tree stops growing and eventually dies (Figure 2D). Vigorous and strong growing trees may survive the attack with some serious deformations and girdling on the stem (Fig 2E).

Figure 2: (D) Dead tree after heavy infestation (E) Deformation/Girdling on the stem (Pic: Davie Moyo)

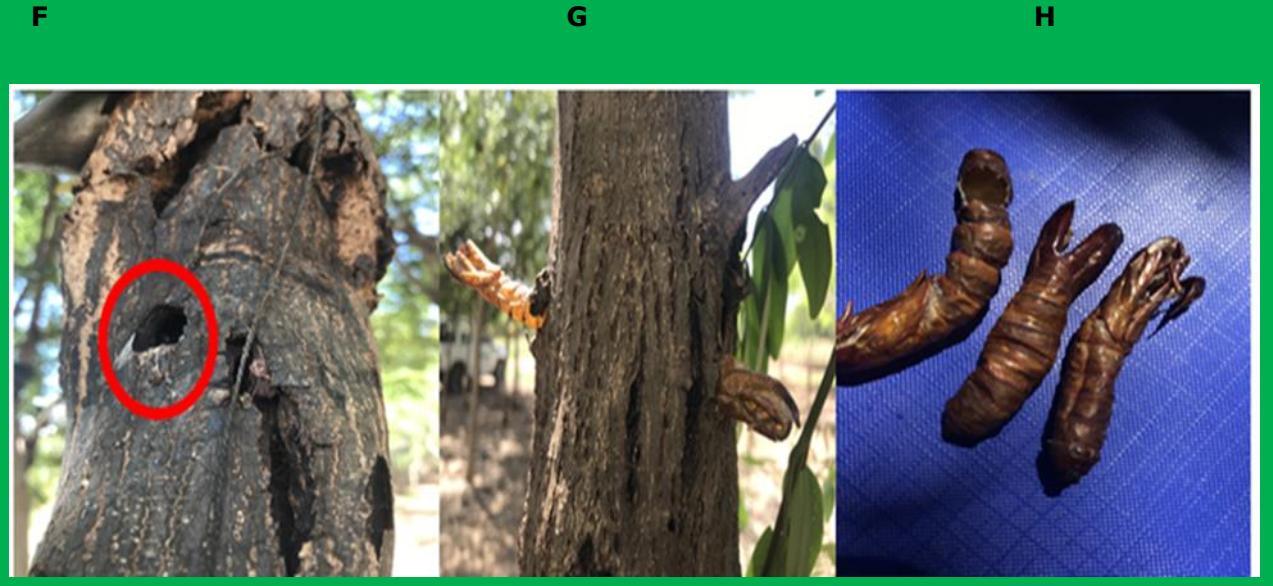
As the pest pupates to adult, it burrows a very big exit hole (Figure 3F) that is also injurious to the plant. Additionally, during the exit time the pest leaves its shell (Figure 3G) on the exit hole as the adult goes elsewhere to seek another host for further reproduction. Many shells (Figure 3H) have been collected in the sites that have been visited and the number of shells define the rate at which the insect is multiplying.

Fig 3: (F) Big exit hole (G) Shells left on a tree stem after ecdysis (H) Collection of shells left after molting (Pic: Davie Moyo)

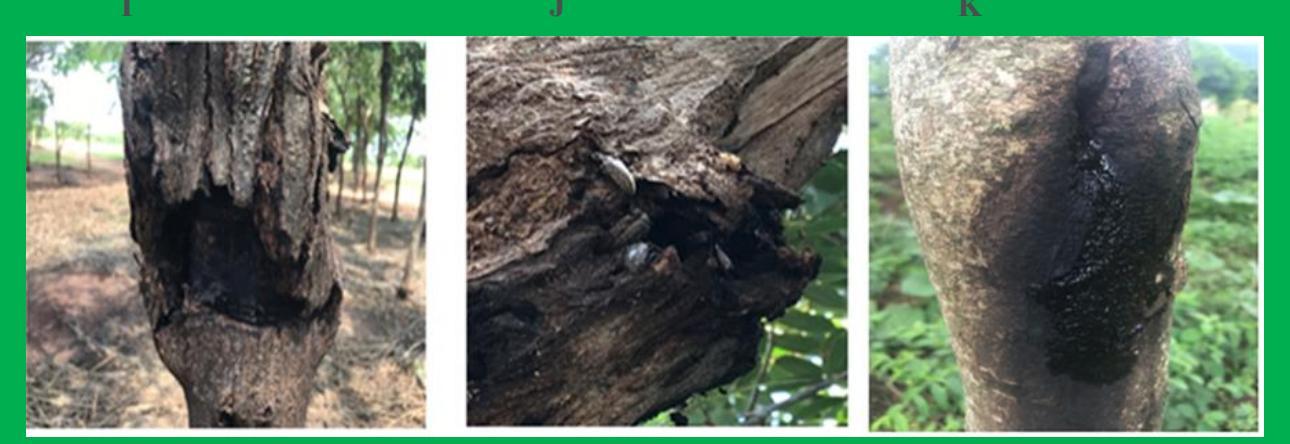
In worse circumstances, the exit holes might enlarge to the extent of exposing the inner cambium of the tree stem (Figure 4I). The enlarged exit holes might attract other opportunistic beetles that might turn it into their habitat (Figure 4J) and further damage that part of the tree where they are residing. In some cases, stem borers are easier to assess not by the actual damage they cause to stems but by resin exudations (Jactel *et al.* 2002) which is as a result of their activities inside the infested stem (Figure 4K).

Fig 4: (I)Inner cambium of the heavily affected tree; (J) Opportunistic beetles habitating in the enlarged exit holes; (K) Exudation

of resin in one of the infected stems. (Pic: Davie Moyo)

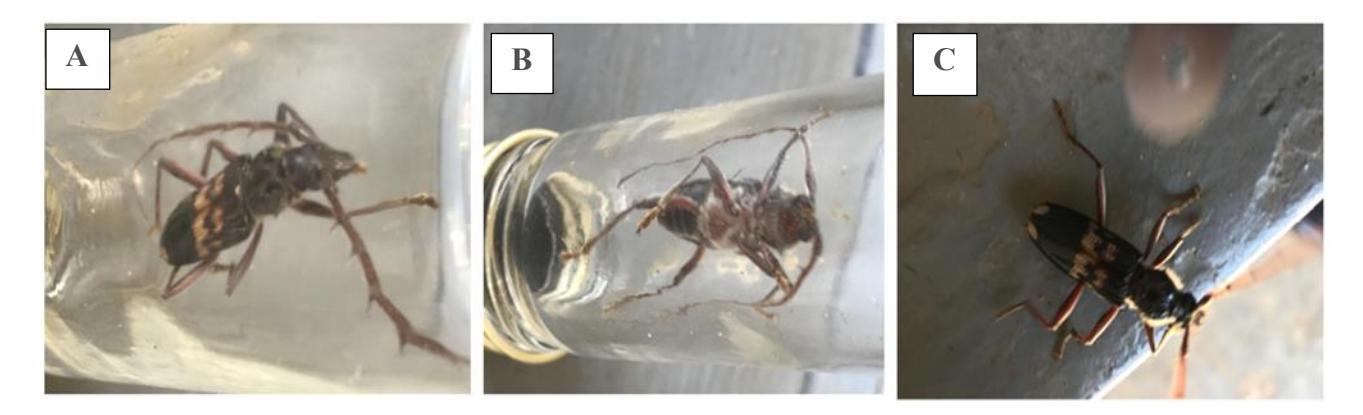
After a period of two weeks an adult insect emerged from the 30 cm piece of wood and it was identified as Eucalyptus long horned borer Phoracantha semipunctata (Figure 1). P. semipunctata is a serious borer pest of Eucalyptus species. In their native Australia, they are considered minor pests attacking damaged, stressed or newly felled trees but they have become established in many temperate and tropical regions worldwide where they have been known to kill even healthy trees. Female beetles are attracted to stressed trees or freshly cut wood where they lay eggs in groups under loose bark. Adults are approximately 14-30 mm long and have shiny, dark brown and yellow to cream-colored areas on their wing covers. Antennae are as long as or longer than the body and the antennae of males have prominent spines (Fig 1).

Figure 1: A male adult *P. semipunctata* in a collecting bottle (A&B) extracted from an infected *E.dunnii* piece of wood. (Pic: Davie Moyo)

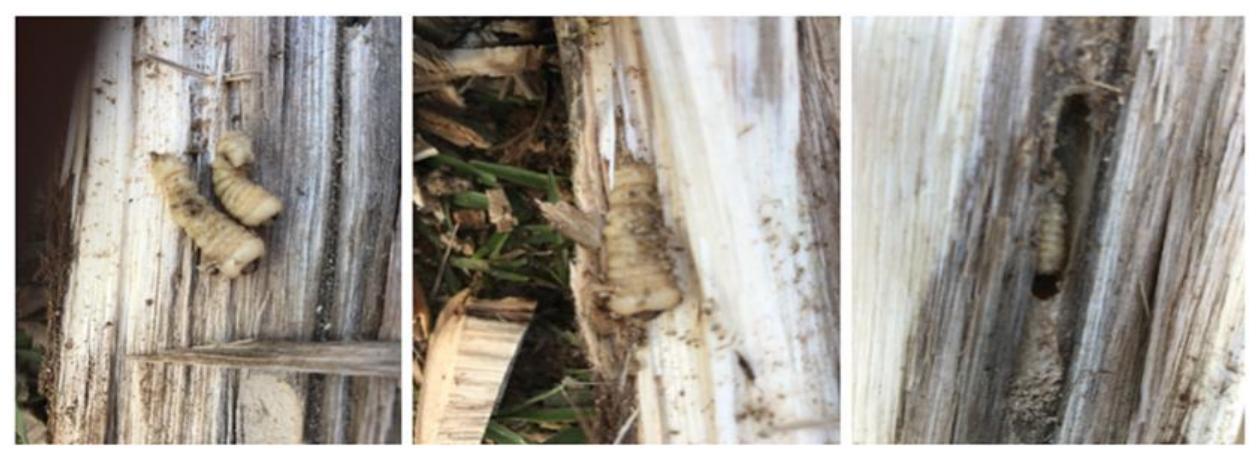
The larvae (Figure 2) tunnel under the bark and into the cambium layer and effectively ring bark the host trees. The larval feeding can rapidly kill the trees or cause significant damage to the timber of affected trees. Mature larvae are cream-colored, legless and may be more than an inch in length. Eggs are ovoid and pale yellow in color.

Figure 2: White grub, a larvae of P. semipunctata on a split piece of E.dunnii (Pic: Davie Moyo)

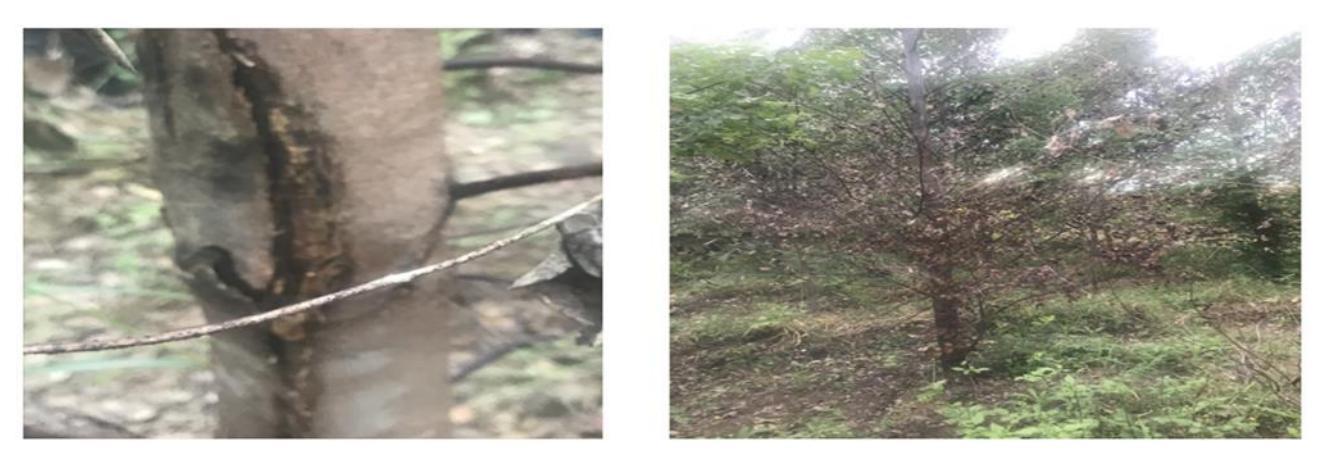
Presence of holes in the bark, stains or oozing liquid on limbs or trunks are common symptoms of long-horned borer attack. Tree girdling often resulting in a thin canopy with wilted or dry leaves and cracked bark (Figure 3) packed with frass (insect excreta and chewed wood particles). Infested trees are often killed in a matter of a few weeks and re-sprouting may occur from the tree base.

Figure 3: A cracked E. dunnii bark (A) and a standing dead tree (B) (Pic: Davie Moyo)

Control methods for *P. semipunctata* are based on good cultural practices and biological control. Such practices involve reducing tree stress through timely silvicultural practices such as weeding, irrigation and protection against injury, planting resistant or tolerant eucalypt species and avoiding activities that disrupt biological control. Cut and split wood in infested sites to hasten drying of wood as moist wood is most suitable for ovipositing. Remove bark from felled logs or wood and place them in sunny environments to prevent resident *P. semipunctata* from emerging and spreading to standing host trees nearby. Infested Eucalyptus trees, branches and wood should be treated or destroyed by burying or burning. Biological control with natural enemies such as parasitic wasps is possibly the best solution of controlling long horned borer populations. There is a need to establish permanent sample plots for monitoring pests to ease pest detection and identification at an early stage.
